SKEWING OF LEADS AFTER BENDING

01-MAY-2012

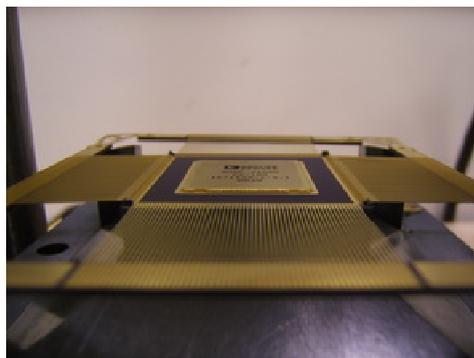
In the photo below, if you look carefully you will see the following:

1. Look all the way in the back, on the left and right side (under the corners of the tie bars), on this special tool you will see the optional tie bar corner cutters. This tool we built for Analog and Boeing has this very expensive option to trim the 4 corners of the tie bars prior to form and trim. Now that you have seen the 2 in the back there are also 2 in the front that did not make it into the photo, this tool had optional tie bar cutting on board the tool to improve forming and reduce handling and skew.
2. Now look at the purple ceramic body. You will see where the GOLD leads are brazed to the body. On each of the 4 corners right near the body where the gold leads attach, you will see 4 protrusions sticking up, these are the castellations that locate the leads and part in the Fancort dedicated tool squarely. This makes skew caused by the tool impossible
